## 2<sup>nd</sup> International Conference on Civil Engineering – Palestine

### ASSESSMENT OF EARLY DAMAGE IN NEWLY CONSTRUCTED LOW VOLUME LOCAL ROADS

Amjad Issa<sup>1</sup>, Fawz Kobari<sup>2</sup>, and Sameer Abu-Eisheh<sup>3</sup>

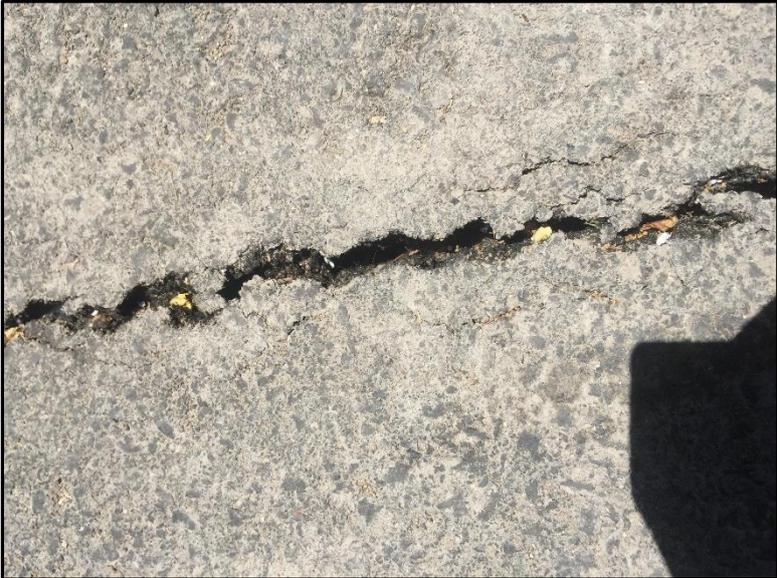
The first case study includes five internal roads in Jaba' town which have the following numbers; R1, R4, R5, R6, and R7, respectively. These roads had longitudinal and edge cracks parallel to the road centerline and to the shoulders. Moreover, longitudinal cracks were noticed along the joint between the asphalt layer and the adjacent concrete shoulder, in addition to similar cracks in the body of road shoulder. The degree of severity varied from low to severe and the width of the cracks ranges from 0.5 to 4.0 cm. These cracks were deep and reached the subgrade. The same cracks in terms of width and depth were noticed also in the shoulders and adjacent natural lands. This fact emphasized that the subgrade soil is weak and needs to be improved, strengthened and stabilized.

**Figure 1.** Centralized longitudinal cracks with medium severity, Jaba'

- Longitudinal cracks were located along the centerline of the road due to the poor subgrade and the absent of drainage facilities such as culverts.
- Edge cracks were also noticed due to the poor subgrade, high level of underground water because of springs, the inadequate pavement thickness, and the unstable condition of subgrade and soil beneath (noting that the existing soil is expansive).

The type of the applied treatment was based on the severity levels. For example, the low severity cracks were treated using the seal coat. The contractor filled the cracks after ensuring reaching to the maximum width of the cracks by the end of summer season. The drainage problem in R7 was solved by installation of 40 cm pipe culvert. This will contribute in minimizing the seepage of the surrounding water ponds through the structure of the road. The medium to high levels of severity cracks were treated by applying concrete injection in to the faults. The depth of the cracks crossed beneath the structure of the road up to the subgrade. The applied concrete through the bore holes would increase the stability of the subgrade and the remaining road layers. The application of such treatment was under the supervision of the municipality engineer. Figure 9 illustrates the proposed treatment.

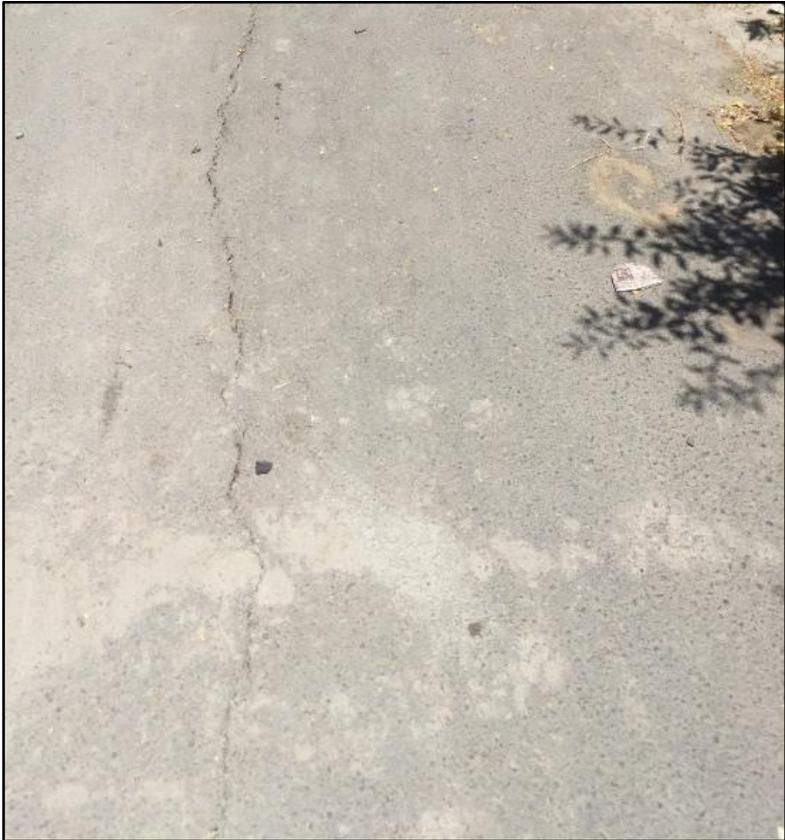
**Figure 2.** Centralized longitudinal cracks with low severity, Jaba'

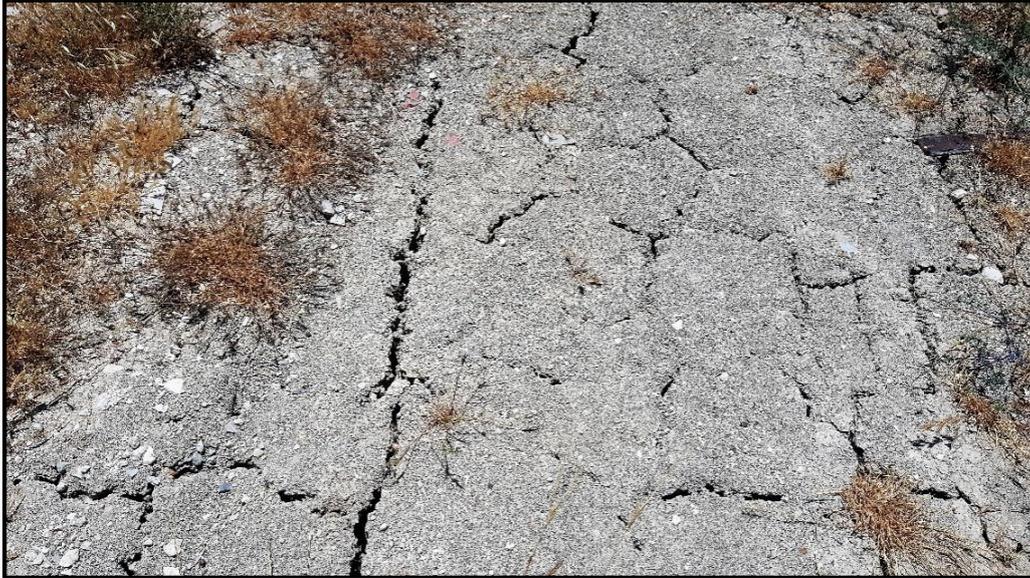
The sub-surface drainage was also one of the main problems in the targeted roads. The local people declared that some springs are located beneath the roads which caused cracks as the soil suffered from expansion (swelling) after being fully saturation with water. The bad drainage of water on both sides of the roads with the absence of culverts was contributed in appearing the different types of cracks as illustrated in Road No. 7. It is worth to mention here that the number of vehicles passing through these roads is very few as most of the roads are dead end roads and providing the accessibility to the internal quarters of the town, thus considered as low volume roads. Accordingly, the effect of the traffic loads can be neglected. Figures 1 to 3 illustrate the existing defects and degree of severity in the targeted roads and adjacent lands.

**Figure 3.** Cracks with different degree of severity in the adjacent lands, Jaba'

- The level of the surrounding natural land is the same as the roads and accordingly this would enhance the negative effect of water on the edge part of the road.

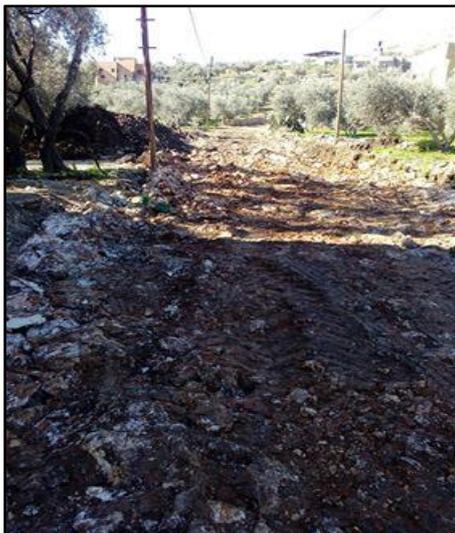
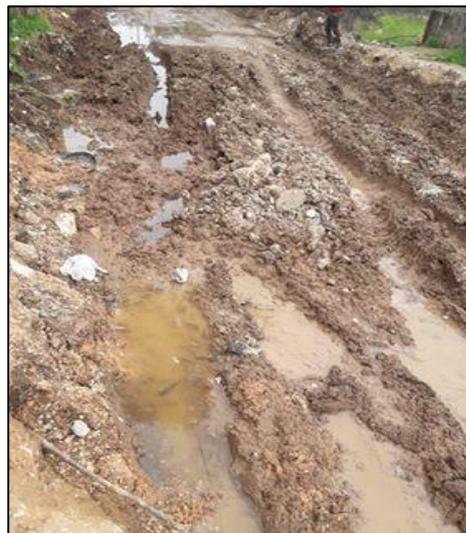
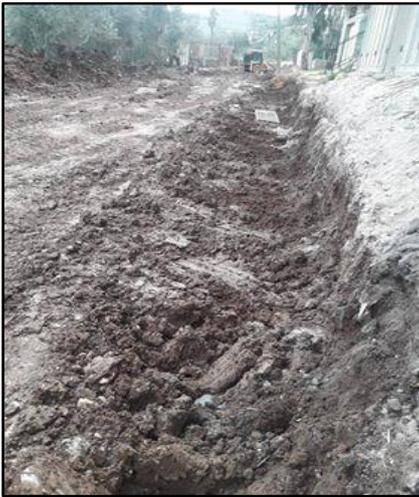
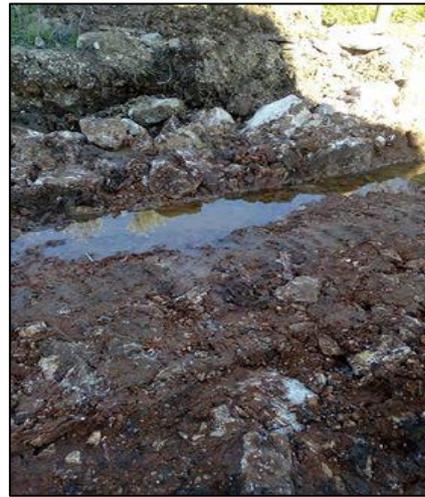
The second case study includes Al-Khirba internal road in Sanour village. The length of the road is about 400 m. The road was under construction in the excavation works and importing rock fill materials for some sections while conducting the first site visits. The existing soil is very poor and classified as A-7-6 which is silty clay soil with red color (UG, 2019). This implies that the soil should be replaced up to certain depth with the help of the supporting layers. The soil is expansive as it swells in the winter and shrinks in summer. Figure 4 depicts a general view for the existing problems in the road, while Figure 5 illustrates the poor nature of the soil (UG, 2019).

**Figure 4.** General view for existing problems in Al-Khirba internal road, Sanour

- It is clear from the previously shown photos that there is weak soil needs to be replaced to a certain depth with the presence of other supporting layers.
- The need for pipe culverts in the low point as the surface of the road is almost level.
- The level of the surrounding houses is taken into consideration in the design to ensure the safe access.
- The reviewed soil tests' reports for the road indicated that the road is located in an area of weak soil type which had bad results in terms of its capacity for expansion and shrinkage (expansive soil). The soil

- The review process for the design plans (existing at local village council) emphasized the need for redesign of the road. The new proposed cross section of the new structural design is illustrated in Figure 8. Moreover, the need for improving the longitudinal and cross slopes is urgent to ensure reaching surface water to the lowest point.

- The new proposed design included replacing the existing soil with a depth of 1 meter instead of 90 cm with an emphasis on 70 cm of rock fill layer to improve and strengthen the base of the road. The proposed design includes also the addition of 30 cm thickness boncor layer, then a 20 cm layer of base course, and finally an asphalt wearing layer with a thickness of 6 cm. This design is compatible with the functional classification of the road (local).

- To ensure that water is well discharged and not collected below the road base, a geotextile layer is proposed below the boncor layer. This will contribute in minimizing the effect of rising water table.

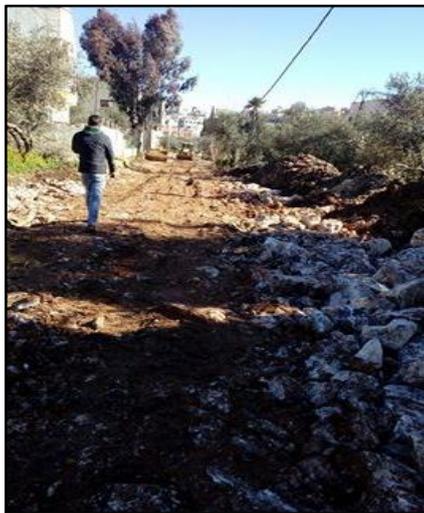
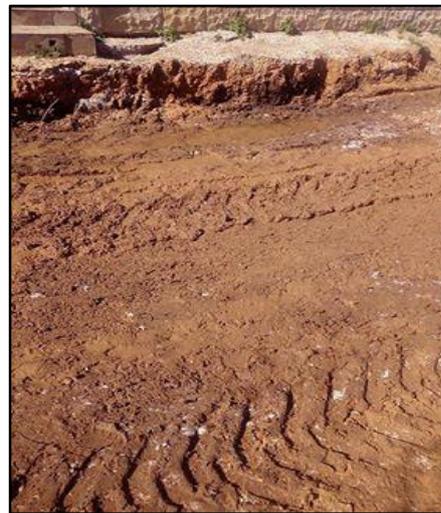
**Figure 5.** Poor nature of the existing soil, Al-Khirba internal road, Sanour

swells in the winter and shrinks in the summer, which negatively affects the pavement structure and the layers above.

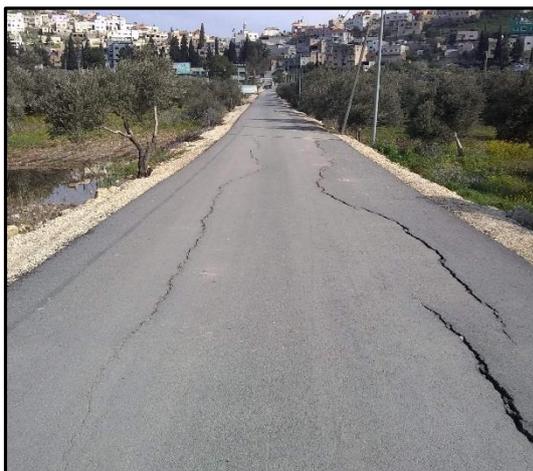
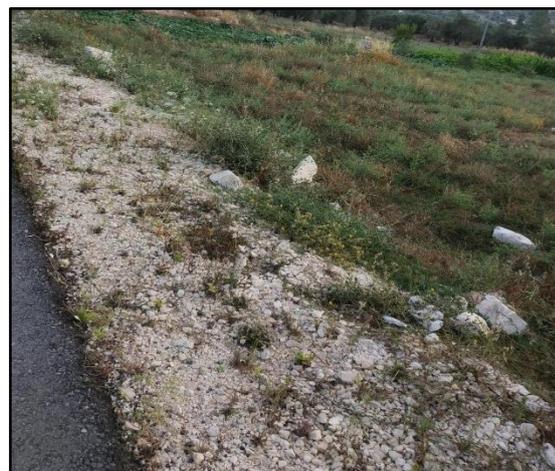
The third case study includes Al-Rabba'at internal road in Sanour village. The length of the road is about 350 m. The road was paved less than one year ago. The existing soil is very poor and classified as A-7-6 which is silty clay soil with red color (UG, 2019). Longitudinal cracks were noticed in the road and with medium to high severity. The soil of the subgrade is noticed to be expansive and the water table is shallow. Figure 6 illustrates the existing pavement defects in the road. The lack for proper drainage in specific sections along the road (lack of drainage facilities such as pipe culvert), as well as the lack in proper compaction for shoulders (the base course material of the shoulders was crumbled and segregated), contributed in increasing and accelerating the failure of the road as illustrated in Figure 6.

**Figure 6.** General view for existing defects including lack of drainage facilities and proper shoulder compaction in Al-Rabba'at road, Sanour

- The high severity of the existing longitudinal and edge cracks is due to the weak subgrade, poor drainage especially for the adjacent and surrounding lands.

- The poor compaction for shoulders led to the dropping and as a result appearing of the cracks.
- The existing design of road is composed from 30 cm thickness rock fill layer, 20 cm base course, and 5 cm asphalt. This design is expected to reduce the impact of high level of water table in the road. However, due to the similarity with Al-Khirba road, the previous proposed structural design is compatible.

- The need for installation of additional pipe culver is urgent to ensure full discharge of collected water (ponds).
- The levels of the adjacent houses should be taken into consideration for future improvements.

- The deep patching and reconstruction are urgent actions to repair the current defects.

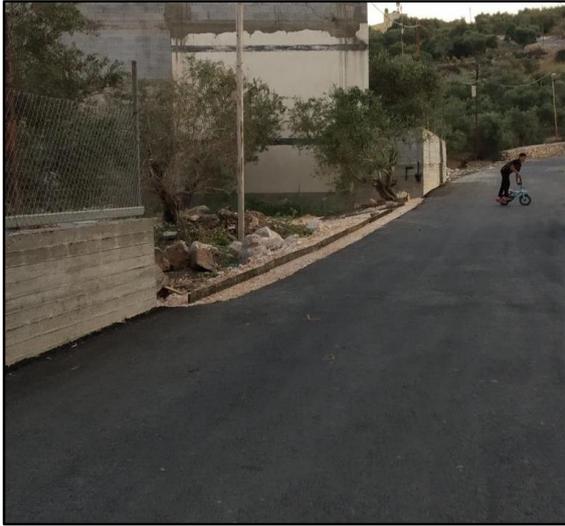
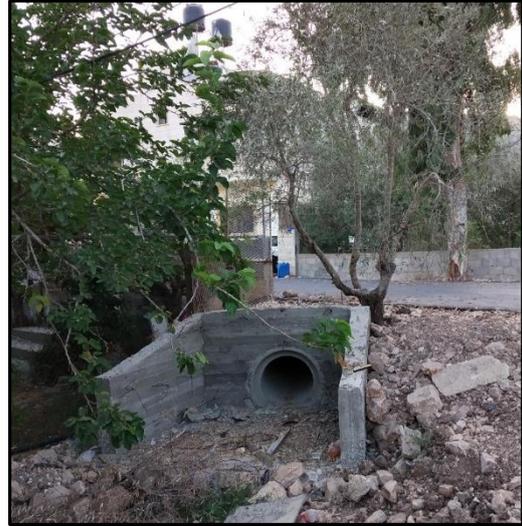
The current situation of the road is good in general as the road was recently paved as illustrated in Figure 10. However, some defects were noticed recently in certain locations in the road as presented in Figure 11. Moreover, the local village council is preparing for the concrete protection for shoulders, which will also protect the asphalt layer. The challenge of the lack of drainage at the low point in the level area in the road is overcome by construction of a pipe culvert of 60 cm diameter taking into consideration the inlet and outlet points as well as the level of entrance for the adjacent houses as presented in Figure 10. The need for cleaning the outlet area is mandatory to ensure smooth discharge of water.

**Figure 10.** General overview of the road and the constructed pipe culvert across the road

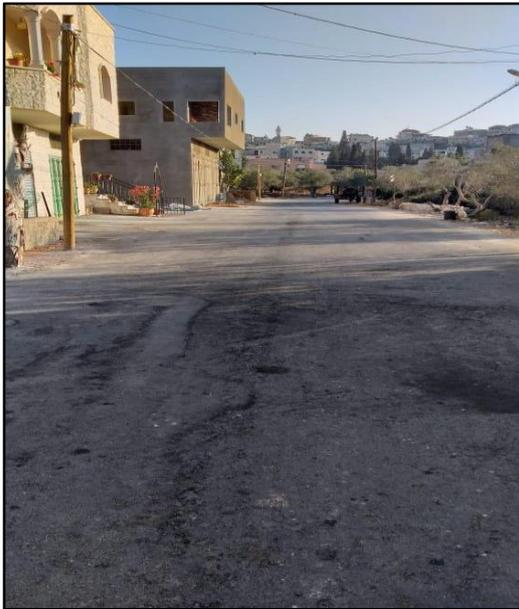
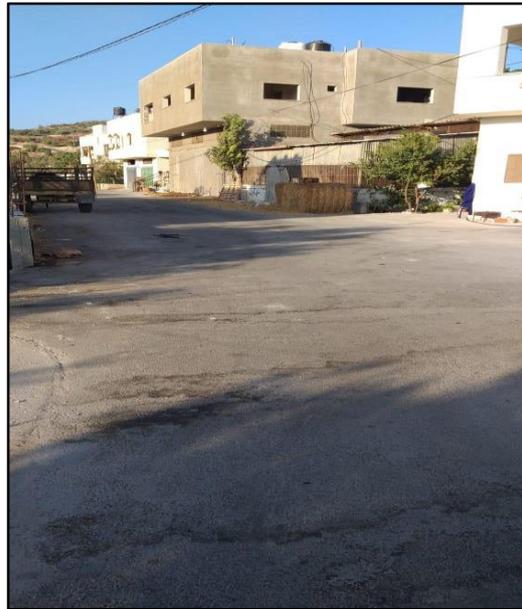
**Figure 11.** Recently noticed defects in Al-Khirba road

- Despite that the overall general pavement conditions are acceptable in Al-Khirba internal road, and where the road was recently paved, it is recommended to wait for the end of maintenance guarantee period to check the quality of implemented works.

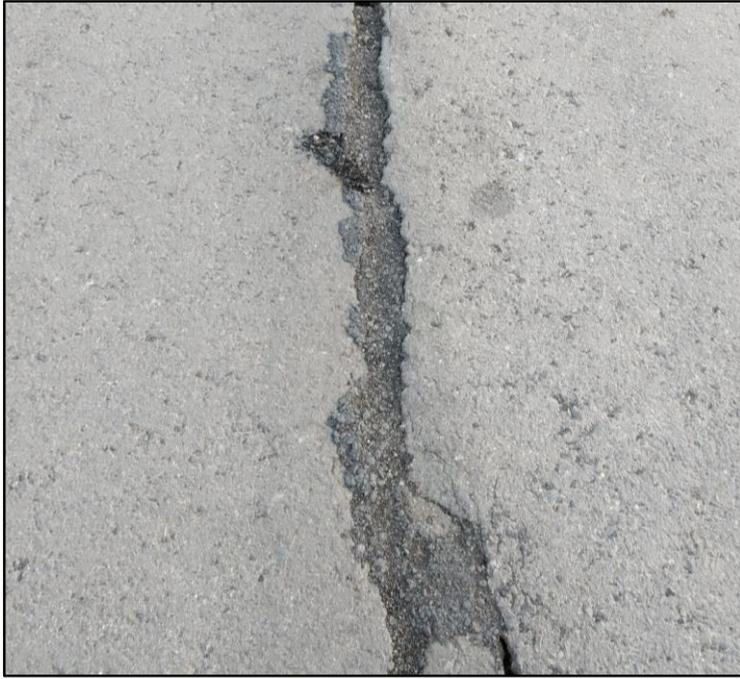
The road is partially treated at specific sections using cold asphalt especially for low to medium severity sections. The applied treatment is not enough and does not cover all defects in the road. The applied treatment is shallow and does not reach to the base of the road. Figure 12 illustrates the application of the cold asphalt. The pavement deterioration in the road is increasing dramatically as shown in Figure 13, which demanded urgent economic and effective actions.

**Figure 12.** The treated sections in Al-Rabba'at road

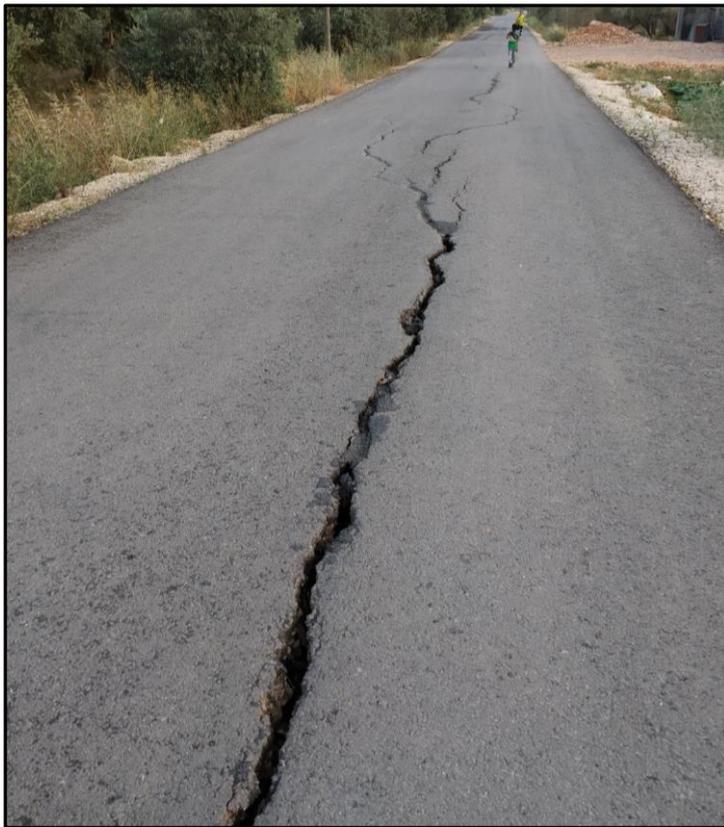
**Figure 13.** The dramatic increasing pavement distresses in Al-Rabba'at road

- Regarding the third case study in Al-Rabba'at internal road in Sanour, the local village council treated some longitudinal and edge cracks in certain low to medium level of severity. These cracks were treated using cold asphalt filling materials. However, the remaining sections were not treated and the existing faults' depth reached the subgrade. Moreover, the width of the existing cracks ranges from 2 to 10 cm. Finally, the overall rating of the road is poor to very poor.

- The existing pavement conditions in Al-Raba'at road is very poor. The authors recommend to treat the existing edge and longitudinal cracks as soon as possible. As the nature of the subgrade soil is similar to that in neighboring Jaba' town, it is recommended to use the same treatment procedure.
